Streamwalk 2008

ASSESSMENT OF PHYSICAL FACTORS
AFFECTING WATER QUALITY IN THE LAMPREY
RIVER WATERSHED

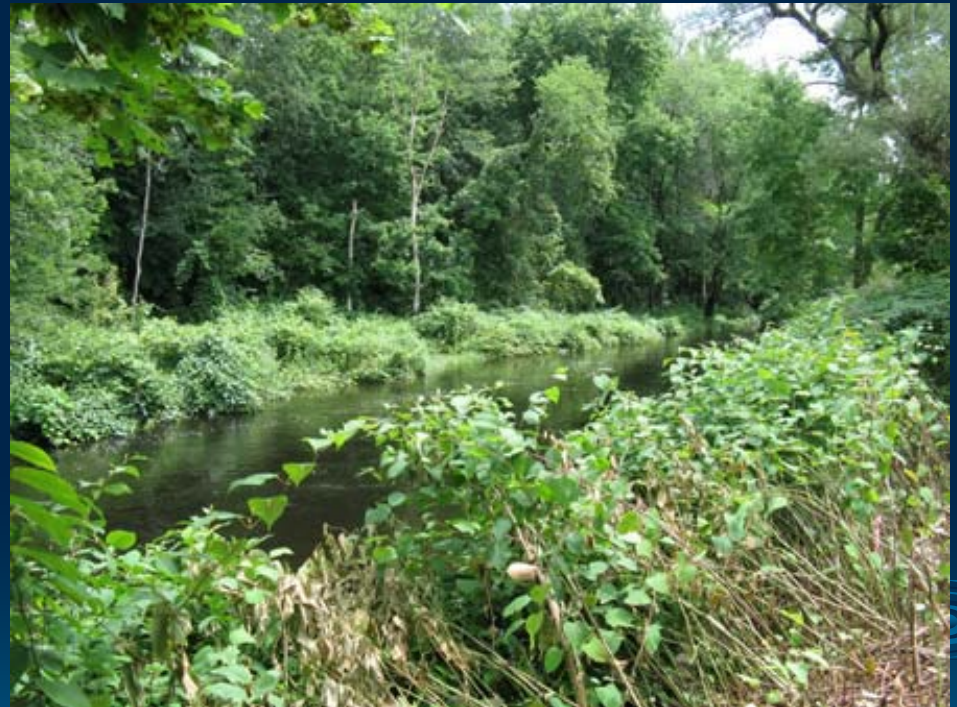
Japanese Knotweed

- Japanese knotweed is prevalent.
- Stormwater is going directly into the river.
- Many culverts are blocked with debris
