Streamwalk 2008

ASSESSMENT OF PHYSICAL FACTORS
AFFECTING WATER QUALITY IN THE LAMPREY
RIVER WATERSHED

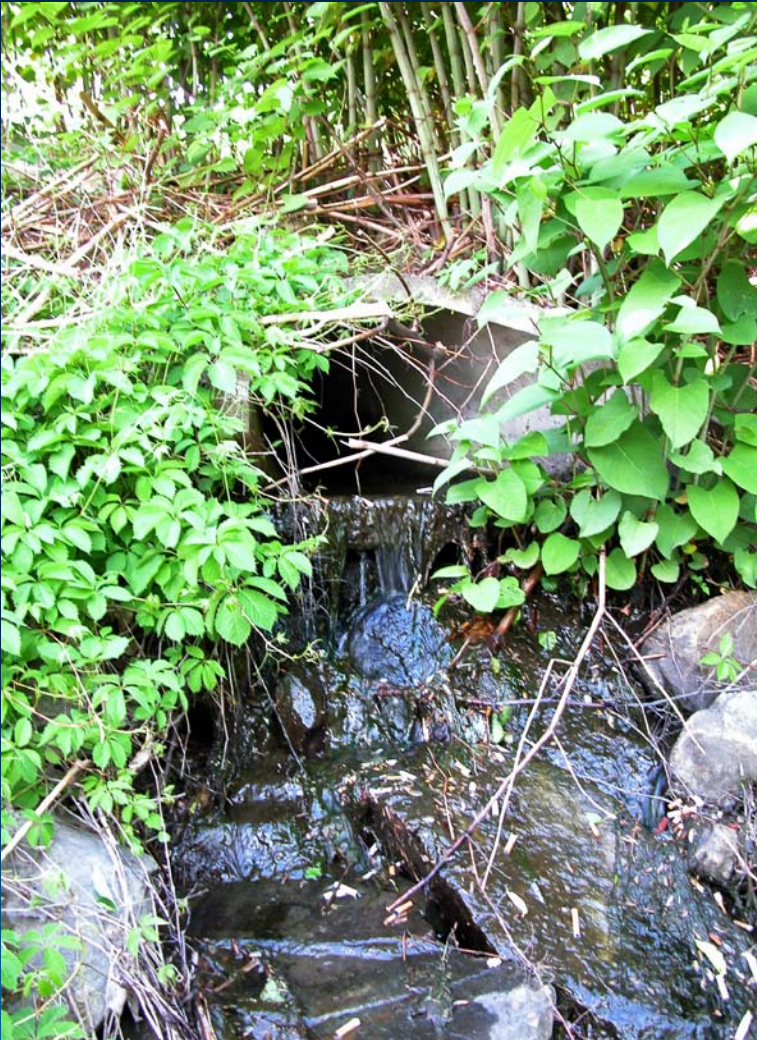
- Japanese knotweed is prevalent.
- Stormwater is going directly into the river.
- Many culverts are blocked with debris

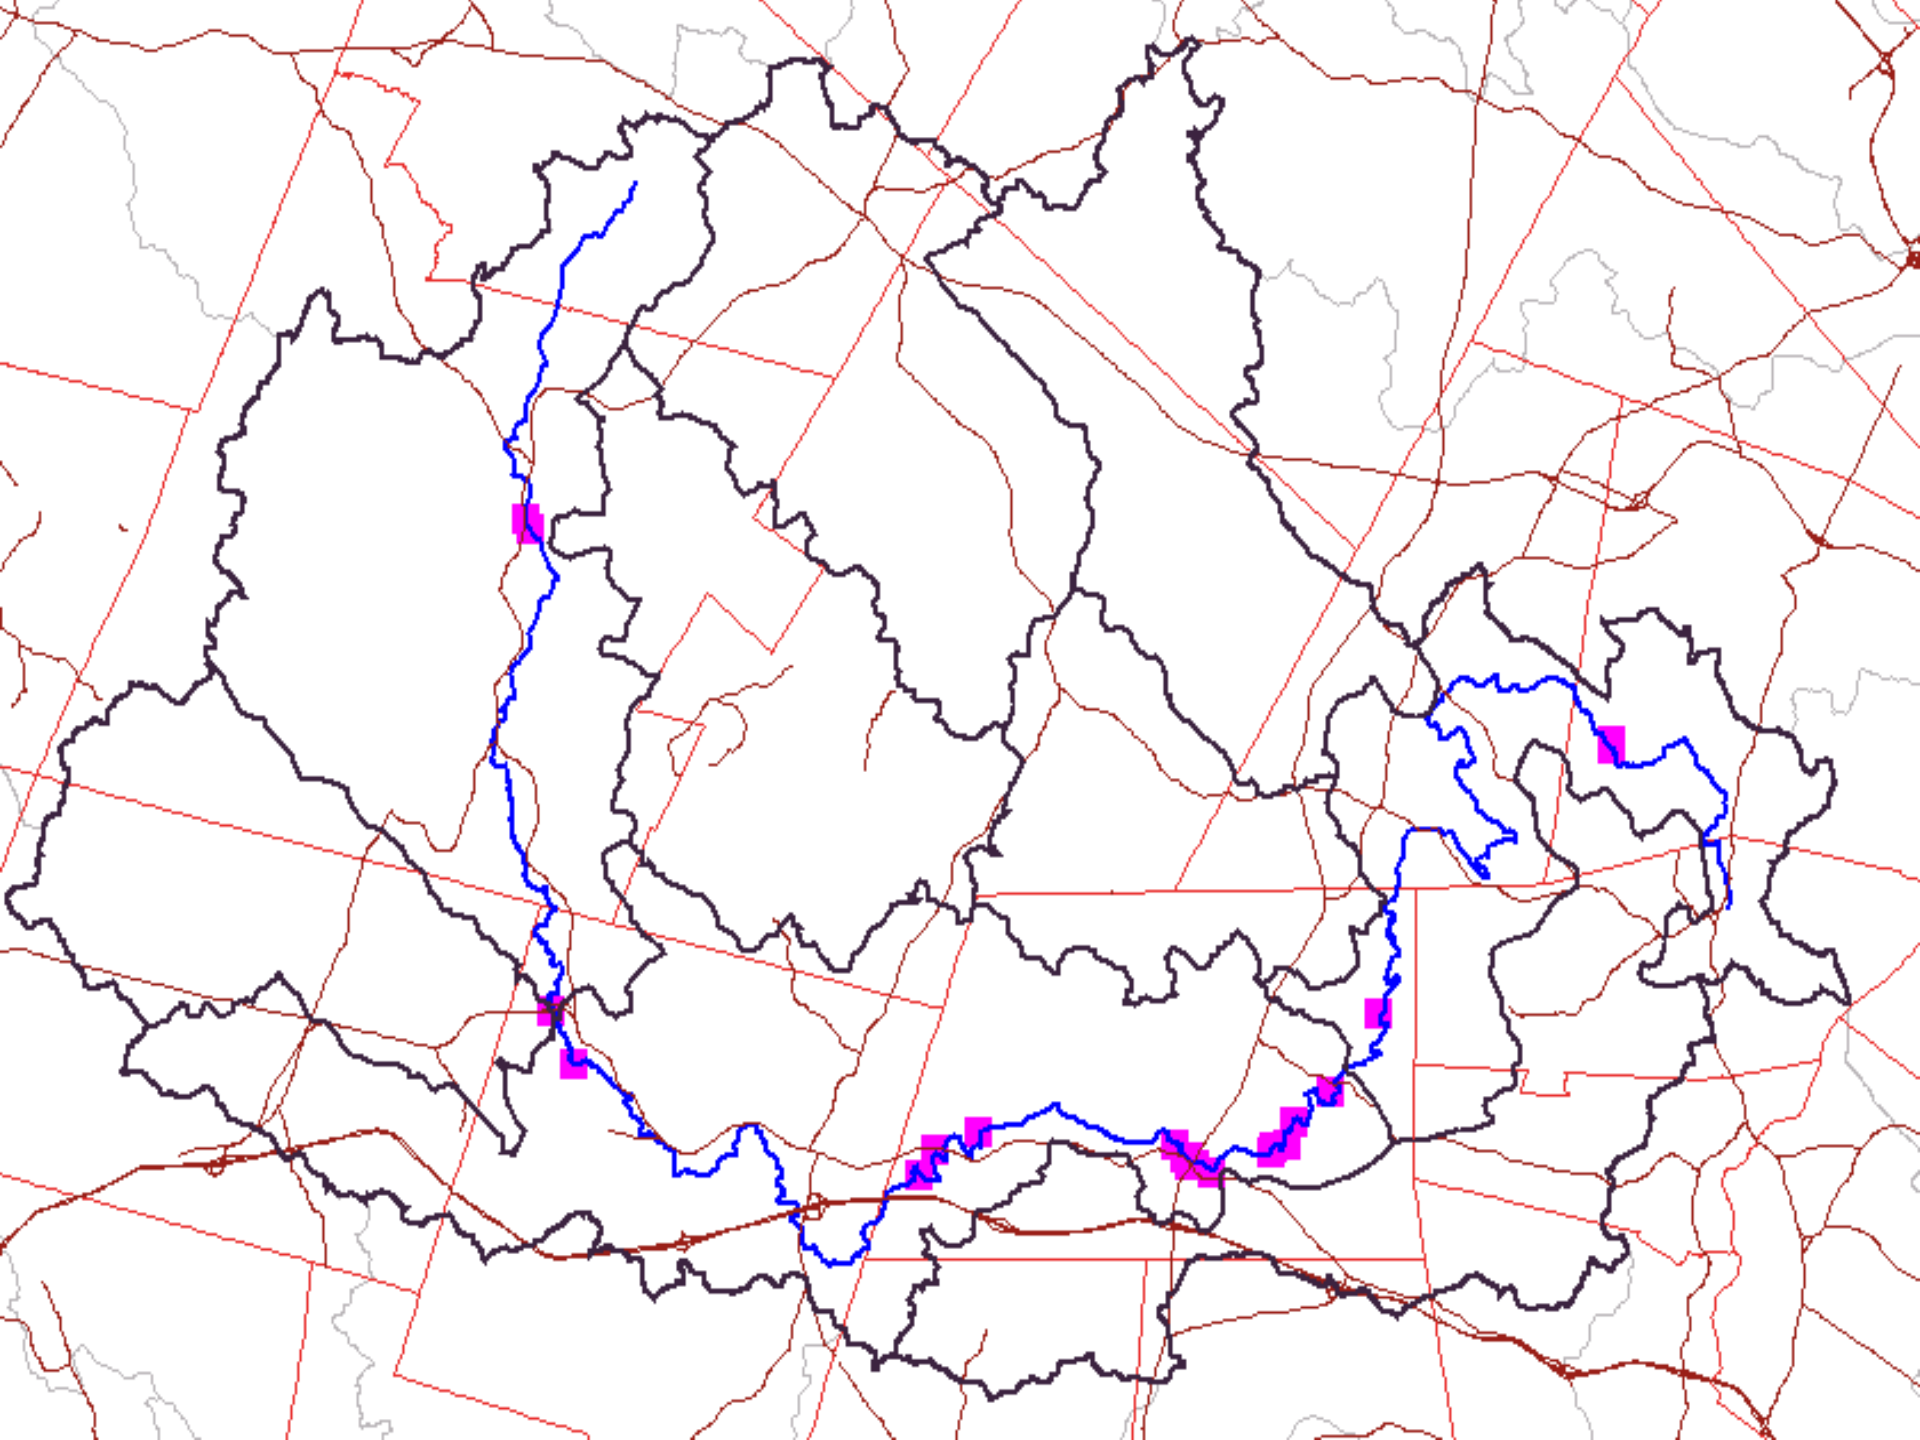
Stormwater Outfalls and Culverts
